Amoco Oil Company

Information on Amoco Wood River CERCLA Sites

4/19/83 SAMPLES

Wood River Pit - Southeast Corner

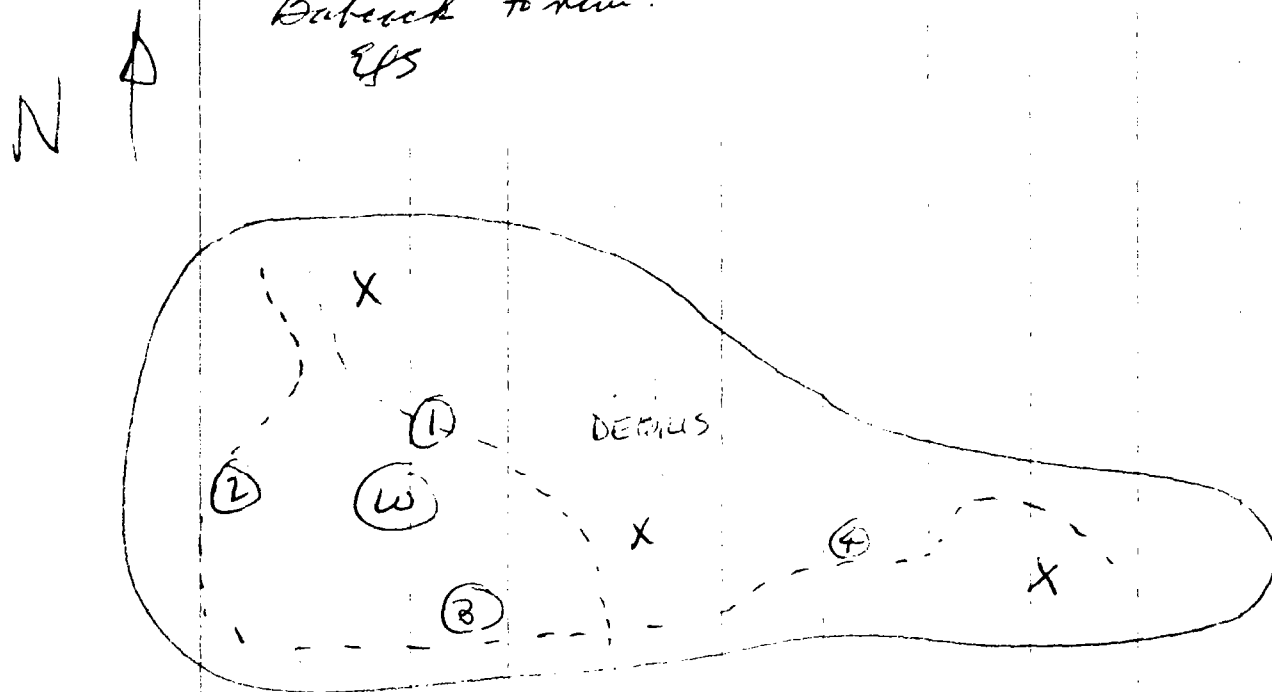
4/19/83
WOOD RIVER

THE FOUR MULTIPLE-GRAB SLUDGE COMPOSITES WERE
COLLECTED ALONG THE LINES SHOWN

THE OIL WAS GRABBED AT THE X'S

THE WATER SAMPLE WAS TAKEN AT (W)
